Fairchild Hall

Fairchild Hall Feasibility Study Phase I & Phase II

PROGRAM

Prepared by Clark | Huesemann and Facilities Campus Planning and Project
Management

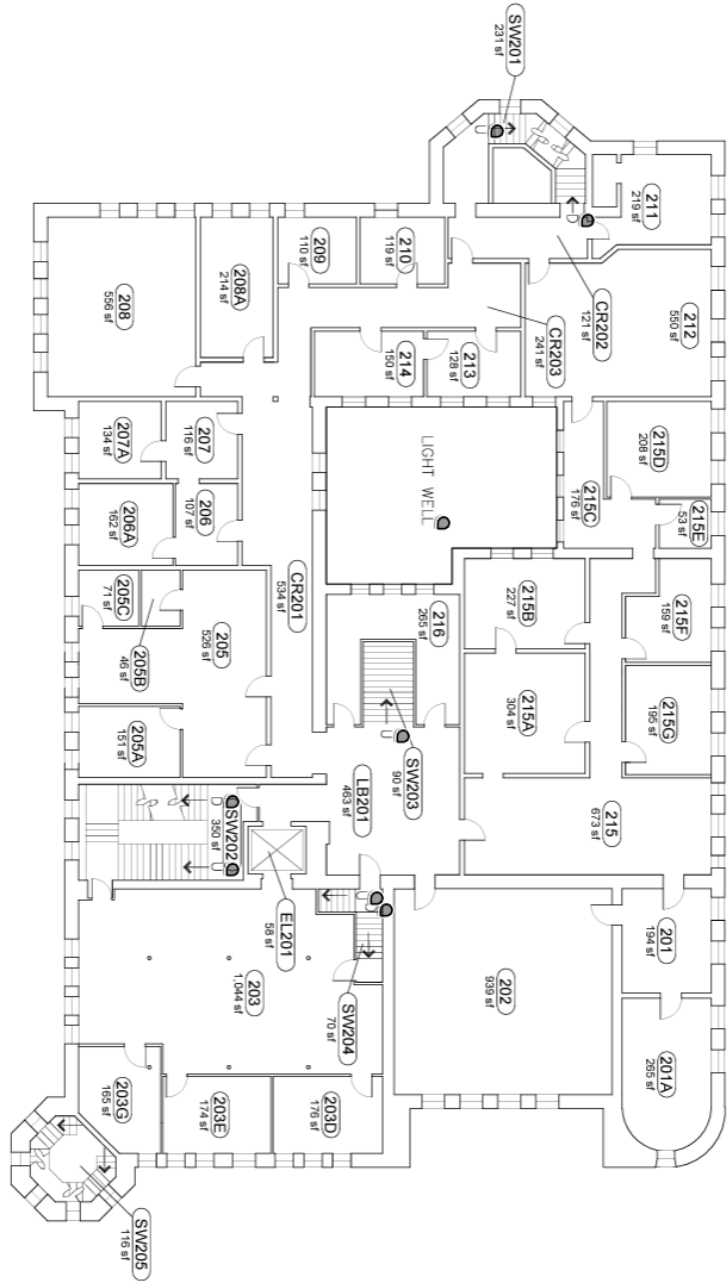
FAIRCHILD HALL	
SECOND	
BUILDING NUMBER	BUILDING NUMBER
F	00030
GSF	BUILT / RENOVATED:
96241	1903, 1998, 2011
UPDATED:	FILE NAME:
2019	00030-FAIRCHILD-2ND.DWG

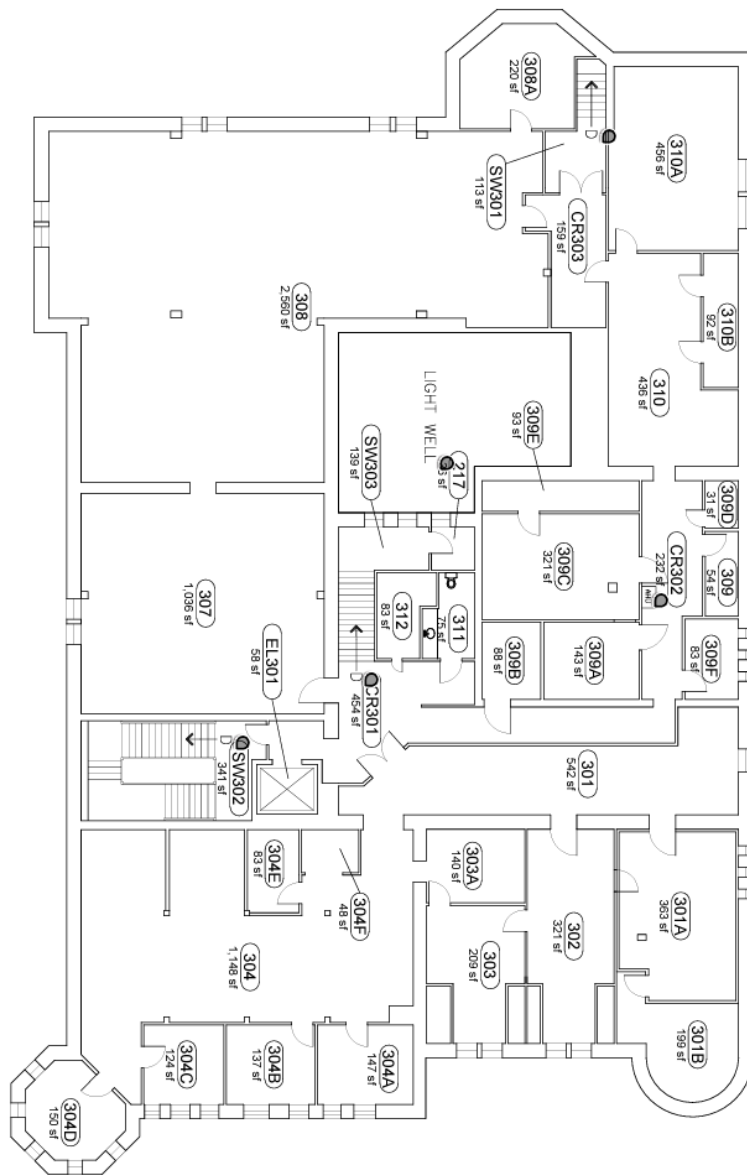
THIRD		FAIRCHILD HALL	
BUILDING ABBREVIATION:	F	BUILDING NUMBER:	00030
GSF:	56241	BUILT / RENOVATED:	1901, 1999, 2011
UPDATED:	2019	FILE NAME:	0030 FAIRCHILD 3RD DWG
