# Kansas State University

Thompson Hall Feasibility Study

2023 10 19

Prepared by clark | Huesemann and Facilities Campus Planning and Project  
Management

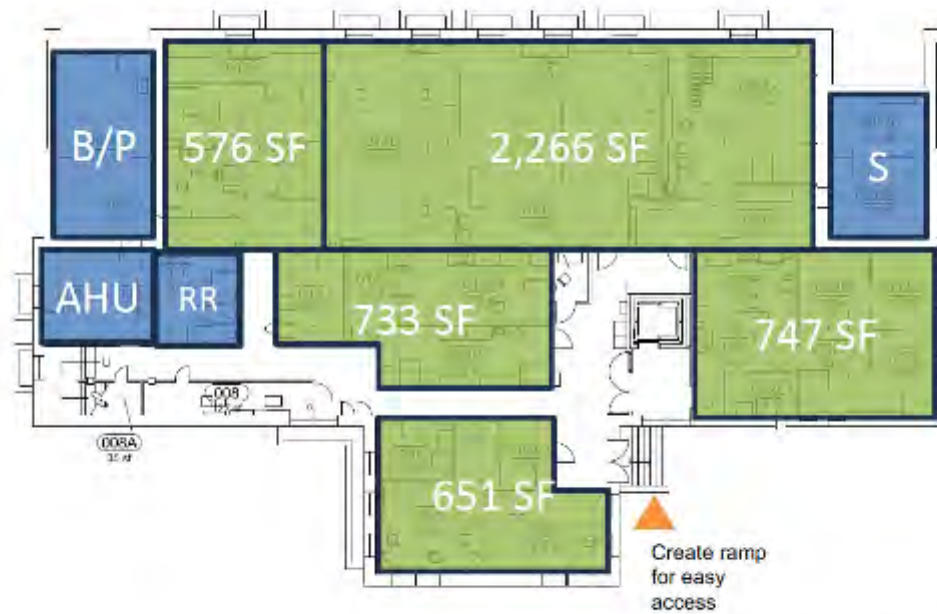
**Basement**

Available nsf = 4,500

The office of Engineering Extension has been identified as a good use for the lower level. Once renovated, the lower level will be able to accommodate the unique needs of this department including a laboratory for Radon testing, a significant amount of storage for outreach programs with easy access in and out, and office functions. In addition, it is desirable to have proximity to two meeting spaces on the first and second level to serve training and workshops hosted by this department.

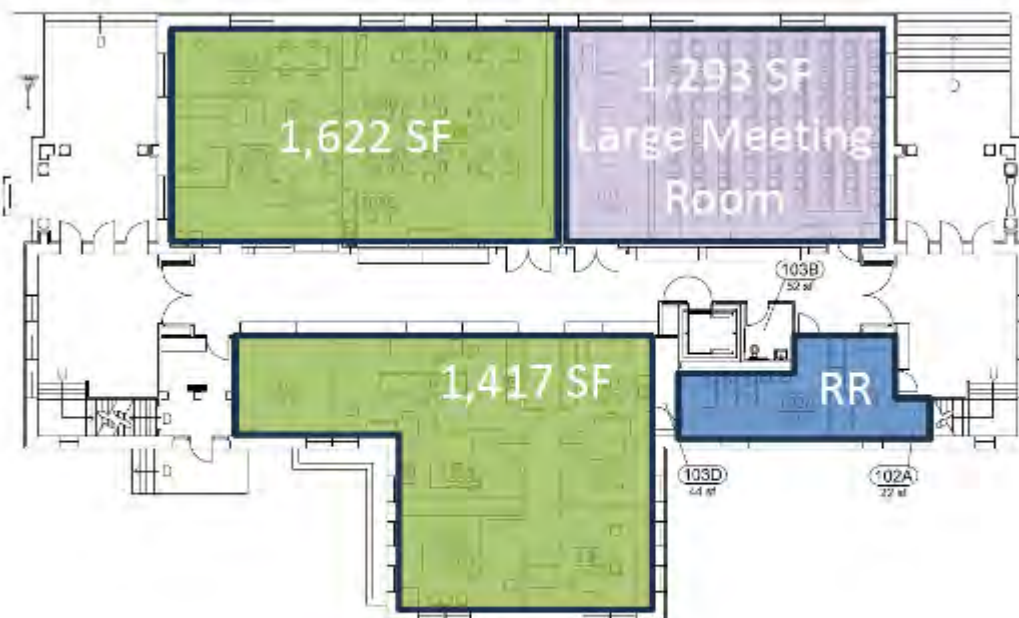
**First Floor**

Available nsf = 4,332

The office of Information Technology has been identified for levels one and two. Their needs for training and meeting space include the flexibility to share training rooms identified on first and second floors. Remaining needs for this department include flexible office space, small and medium meeting rooms, and general office support.

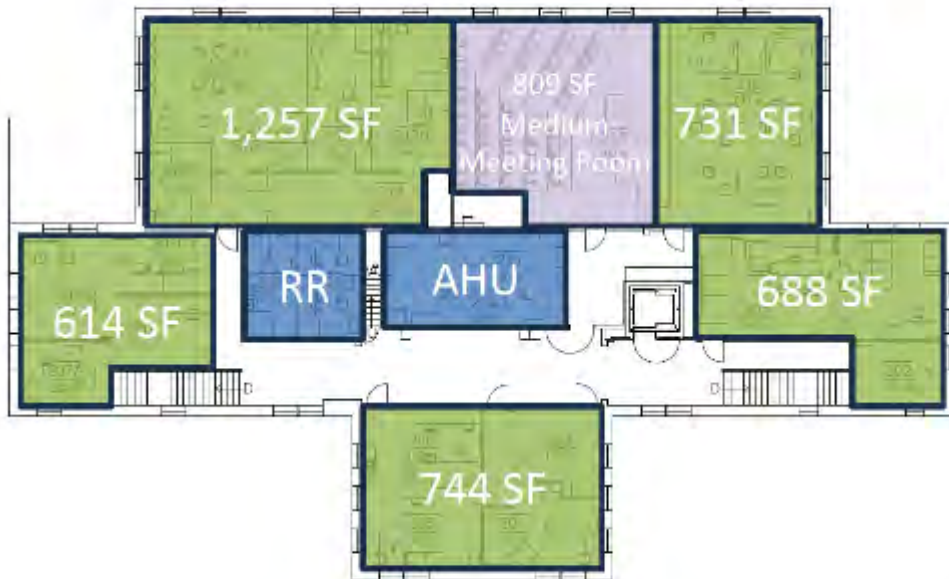
**Second Floor**

**Available nsf = 5,256**
